GUIDELINES FOR USE OF **ASPHALT OVERLAYS** TO REHABILITATE PCC PAVEMENTS

Adriana Vargas-Nordcbeck, Ph.D.
Nam H. Tran, Ph.D., P.E., LEED GA

National Center for Asphalt Technology
At Auburn University

January 2024

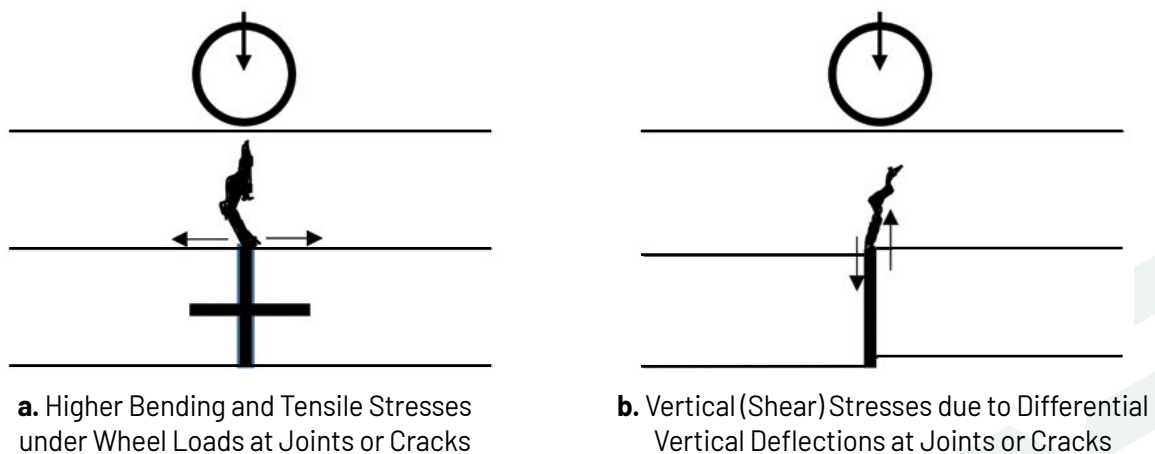
Figure 2.1 Reflection Cracking Induced by Wheel Loads (Von Quintus et al. 2009)

1. If the PCC has poor load transfer between slabs, such as jointed concrete pavements without dowel bars or with deteriorated dowel effectiveness, high vertical deflections can occur when wheel loads move across the joint or crack. This deflection at the joint or crack causes high tensile stresses at the bottom of the asphalt overlay (Figure 2.1a). In addition, differential vertical deflections across the deteriorated joints and cracks under traffic result in shear-stress concentrations in the asphalt overlay (Figure 2.1b). High deflections can develop at joints or cracks due to the gradual reduction of load transfer or the development of voids beneath the PCC at those locations. Thus, reflection cracking driven by traffic loadings is a combination of shear and tensile-fatigue stresses that depend on the magnitude of the vertical deflections across the joint or crack. The important factors include the

magnitude of the wheel load, the amount of load transfer across the joint or crack, and the subgrade support under the slab at those locations.

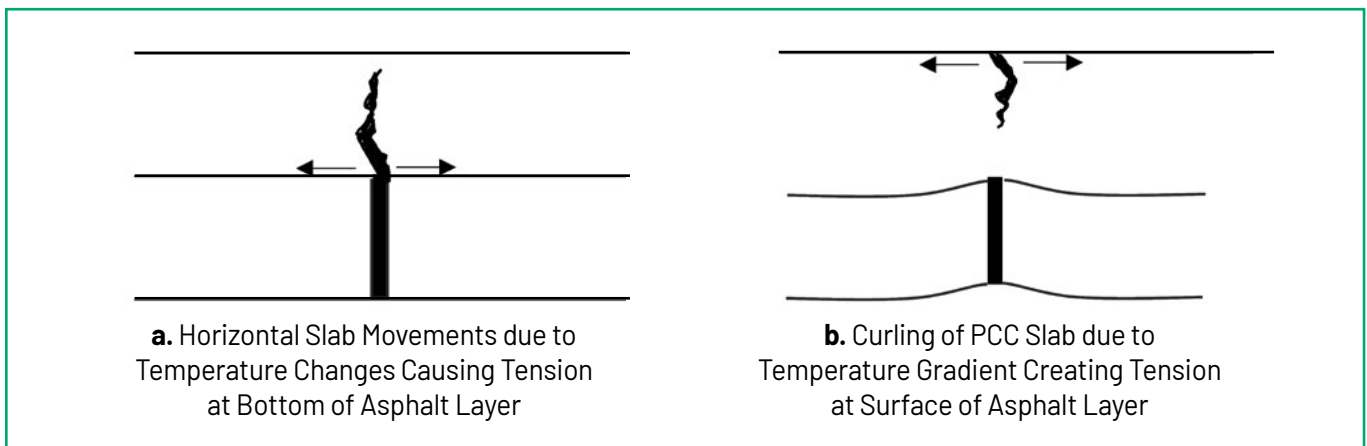
Figure 2.2 Reflection Cracking Induced by Temperature Changes in PCC Slabs (Von Quintus et al. 2009)

1. The primary environment-related reflection cracking mechanism starts with horizontal movements concentrated at joints and cracks in the underlying PCC pavement due to expansion and contraction in the PCC slab due to daily and seasonal temperature changes. Slab movements lead to concentrated tensile stresses and strains at the bottom of the asphalt overlay directly above joints and cracks, initiating cracking at the bottom of the asphalt overlay and propagating upward (Figure 2.2a). This mechanism depends upon the magnitude and rate of temperature change, slab geometry, the opening of the joint or crack, and the properties of the asphalt overlay.

2. The secondary environmental-related mechanism is due to the curling of PCC slabs caused by a temperature gradient within the slab. Slabs curl upward when the top of the slab is cooler than the bottom, and they curl downward when the opposite occurs. An upward curl between adjacent slabs

results in tensile stresses at the surface of the overlay above the joint, which can cause a crack to initiate at the surface and propagate downward (Figure 2.2b). In winter, the stiffness of the asphalt overlay increases, and it can lose the ability to relax under strain. Over time the surface of the asphalt overlay also becomes more brittle due to aging, resulting in its loss of strain tolerance. This mechanism depends on the magnitude and rate of slab curling and the properties of the asphalt overlay during cold temperatures.

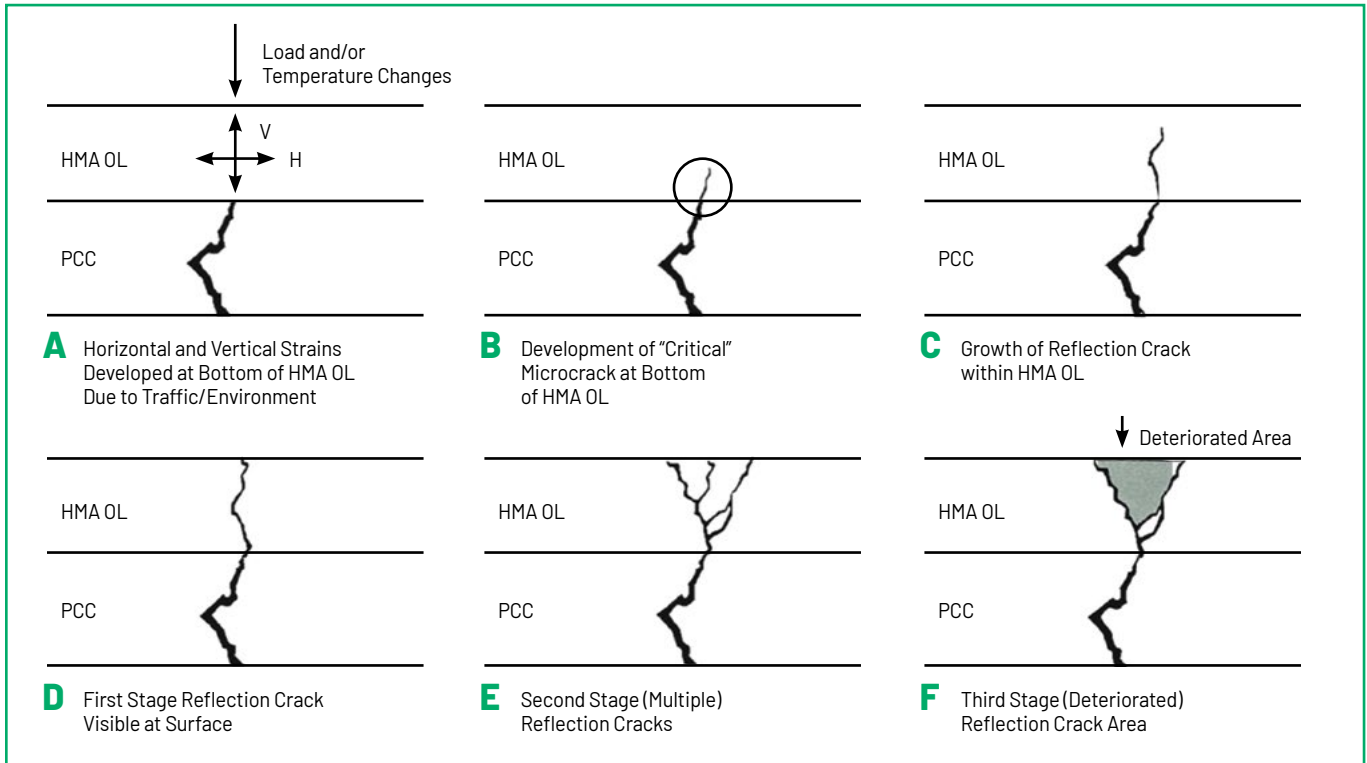
Figure 2.3 Growth Mechanisms Associated with Reflection Cracking (NAPA 1999)

In summary, asphalt overlays on PCC pavements are subjected to several high strain mechanisms that can occur simultaneously. As illustrated in Figure 2.3a, the combined strain and stress concentrations at the bottom of the asphalt overlay eventually cause cracks at the bottom of the asphalt overlay (Figure 2.3b). Due to cyclic temperature changes and repeated traffic loads, the cracks will grow and reflect upwards to the surface of the asphalt overlay (Figure 2.3c and d). As this process continues, multiple reflection cracks will form, causing portions of the asphalt overlay to deteriorate (Figure 2.3e and f). Figure 2.4 shows a deteriorated reflection crack area in an asphalt overlay over an existing PCC pavement, leading to reduced serviceability and shortened service life of the asphalt overlay. Thus, reflection cracking must be addressed in the rehabilitation selection process, described further in the following section.

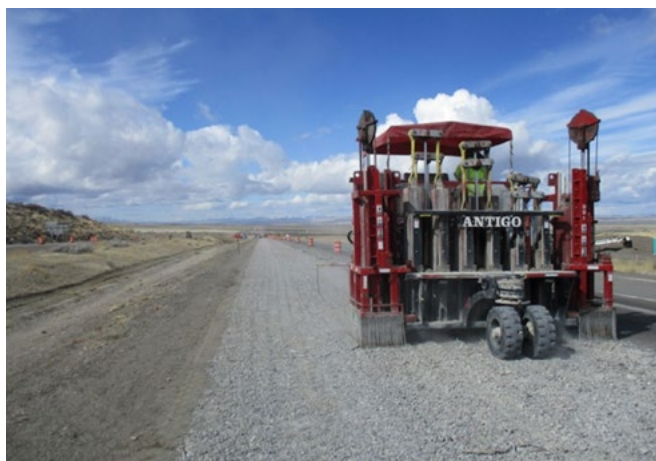
a. Multi-Head Breaker

b. Three-Roller Compaction Process

Figure 3.4 Multi-Head Breaker and Compaction Equipment for Rubblization of PCC Pavements (Courtesy of Antigo)

The MHB has twelve to sixteen 1,200- to 1,700-lb drop hammers arranged in pairs, half in a forward row and half diagonally offset in a rear row. This design ensures continuous breakage from side to side. Each pair of hammers is attached to a hydraulic lift cylinder and can develop 1,000 to 8,000 ft-lb of energy based on lift height and cycle at a rate of 30 to 35 impacts per minute. The drop height can be adjusted during operation to control breaking energy on PCC pavement. The machine is 8 feet wide with 12 hammers, each 8 inches wide, and can have wings added to each side for a total width of up to 13 ft. With individual control of each lifting cylinder, the breaking width can range from 2.67 ft to 13 ft. The MHB is capable of rubblizing a full lane width of pavement in a single pass. It is equipped with a screen to protect personnel and vehicles from flying chips during fracturing.

After the fracturing process, a smooth steel drum vibratory roller with raised Z-grids on the drum (Z-grid roller) with a gross weight of at least 10 tons is used in the vibratory mode for two passes to further fracture the surface particles and to begin to settle and seat the rubblized pavement. A pneumatic-tire roller with a gross weight of 10 to 25 tons is then used to further settle and seat the rubblized pavement for slab thicknesses of 8 inches (203 mm) or thicker. Finally, a smooth steel drum vibratory roller with a gross weight of at least 10 tons, operated in the vibratory mode, is used to settle the rubblized pavement and provide a smooth surface for the asphalt concrete overlay. Figure 3.4 shows an MHB in operation and three rollers used for compacting the rubblized pavement.

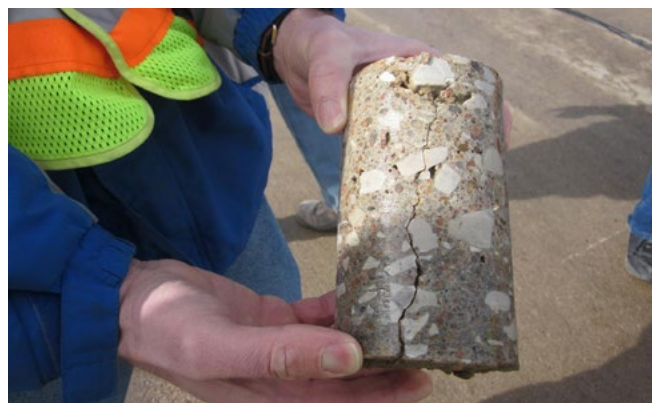
Figure 3.7 Coring for Verifying Through-Slab Cracking (Courtesy of Antigo)

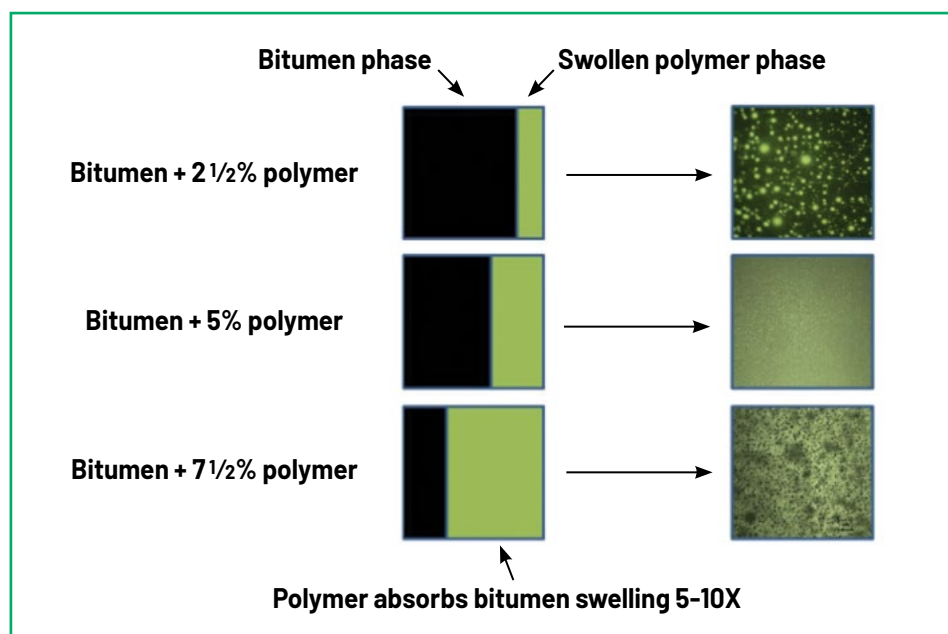
Figure 5.5 Dispersion of polymer in asphalt binder at different proportions (Timm et al. 2012)

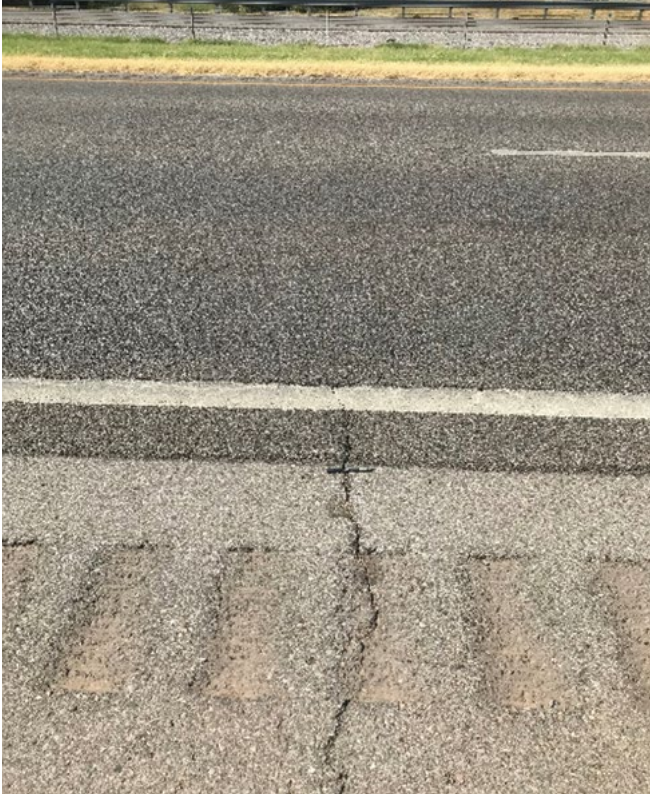
Figure 5.6 HiMA mixture on Oklahoma's I-40 (Vargas-Nordbeck and Musselman 2021)

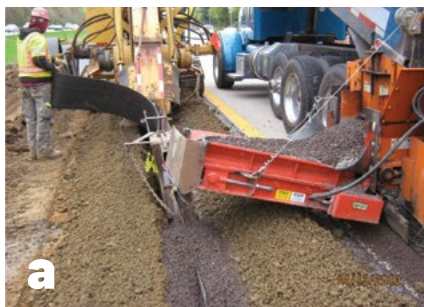
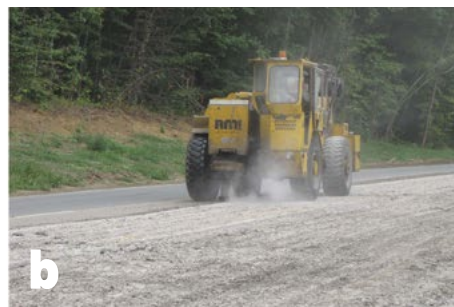
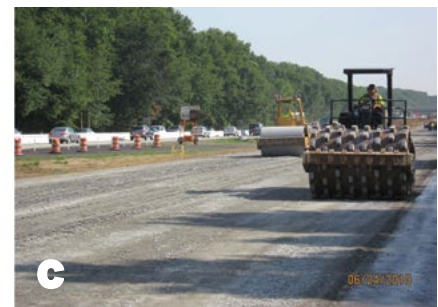
Figure 6.3 Rubblization of JRC: a) Installation of geocomposite edge drain, b) Rubblization of JRC, and c) Compaction of rubblized JRC (Courtesy of NJDOT)

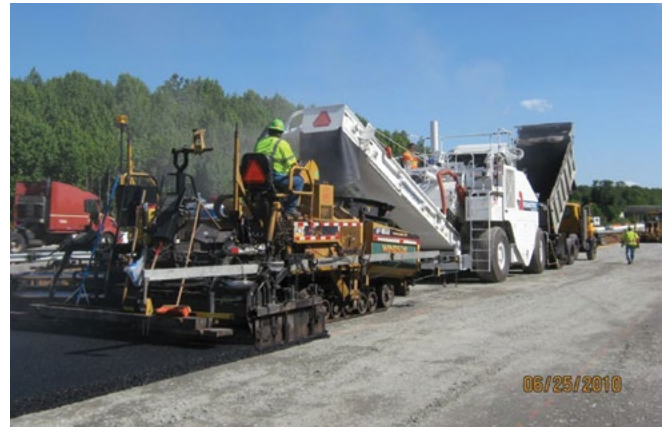
Figure 6.4 Construction of BRBC Layer over Rubblized JRC (Courtesy of NJDOT)

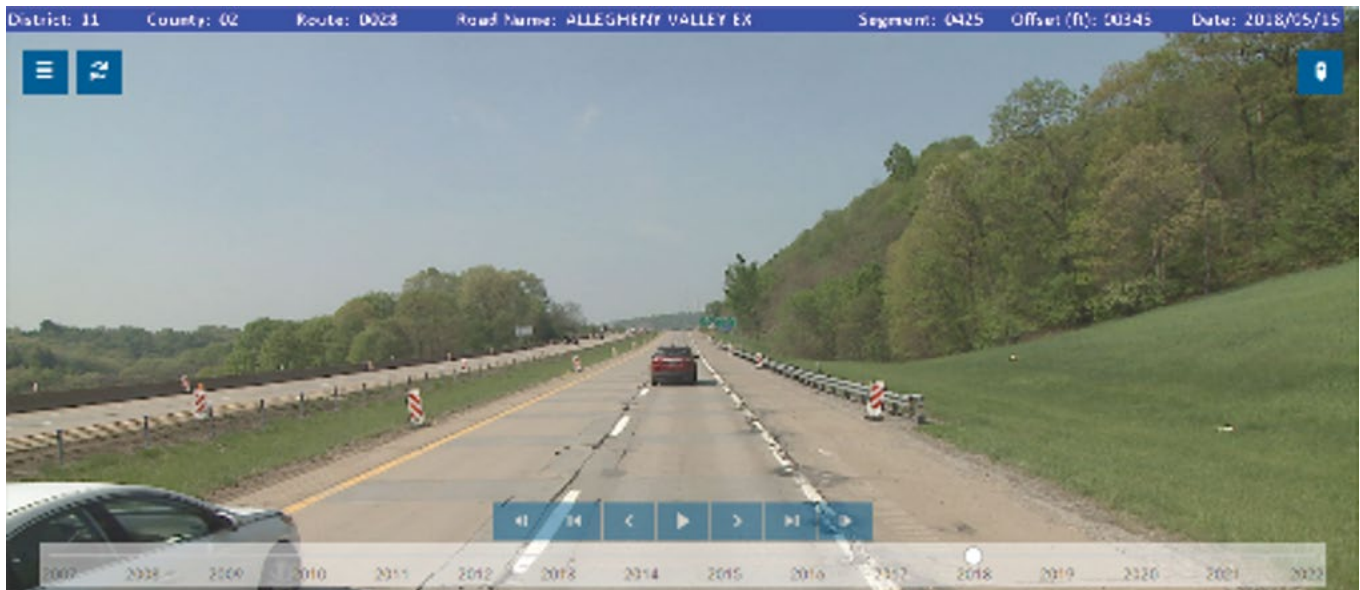
Figure 6.6 Surface Conditions of SR-28, Section A55 in Allegheny County in 2018 Before Rehabilitation (Courtesy of PennDOT)

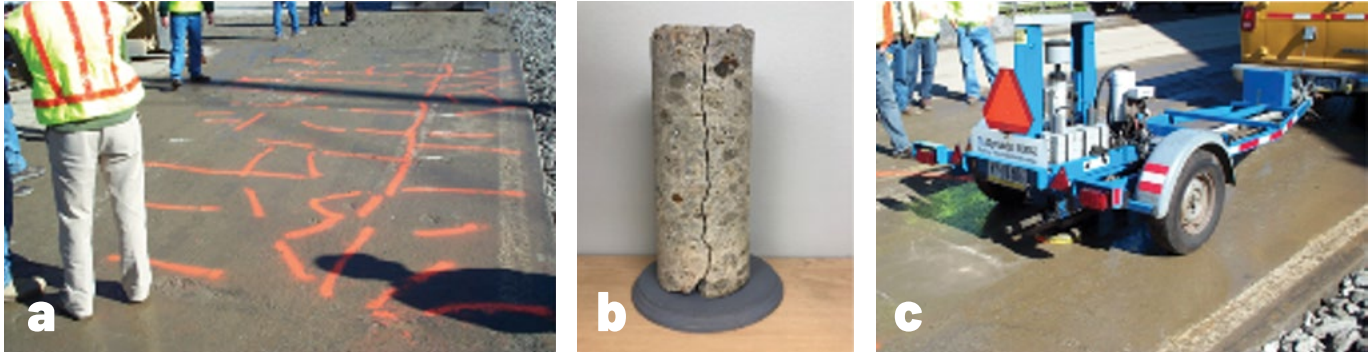
Figure 6.8 Establishing Fracturing Patterns: a) Verifying Cracking Pattern, b) Verifying Crack Depth, and c) Verifying Elastic Modulus using FWD (Courtesy of PennDOT)

For B&S fracturing, the pattern involved a 30-inch hammer lift height and a 24-inch hammer strike spacing. In contrast, the C&S pattern for the 10-foot outside shoulder was set at an 8-inch hammer lift height with a 24-inch hammer strike spacing. The 4-foot inside shoulder had a variable C&S pattern, ranging from 20 to 30 inches in hammer lift height and 24 to 30 inches in hammer strike spacing. Notably, the total hammer weight of the MHBT Badger Breaker hammers utilized was considerably lighter than the 12,000-lb hammer of the T8600.

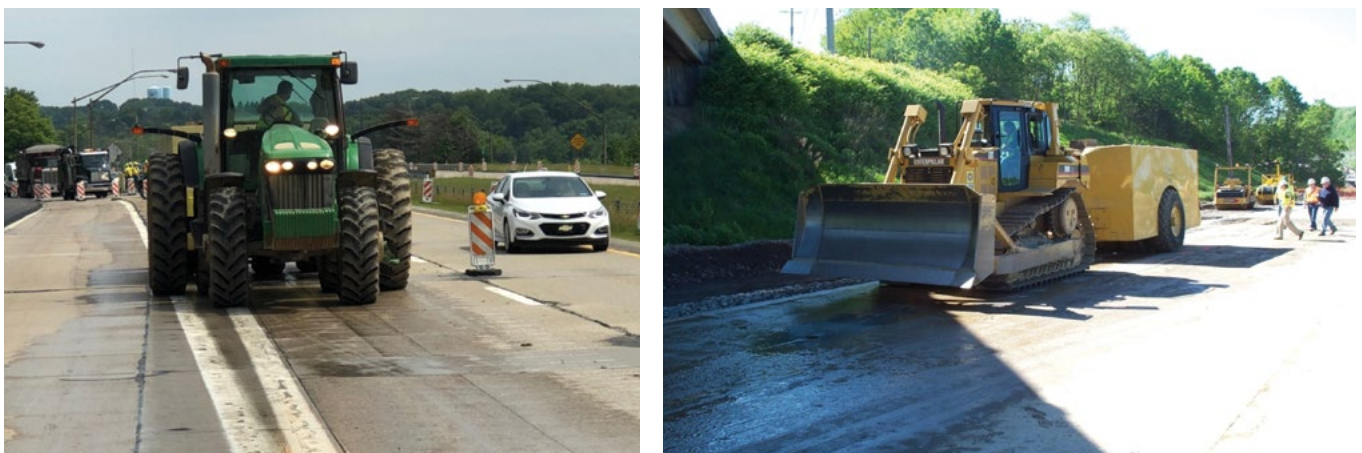
Figure 6.9 Seating JRCF with 50-ton Pneumatic Tire Proof Rollers (Courtesy of PennDOT)
